MARYLAND INVENTORY OF
HISTORIC PROPERTIES

National Register of Historic Places
Registration Form

historic name Valley Mill House

street & number 1600 East Randolph Rd. ☐ not for publication

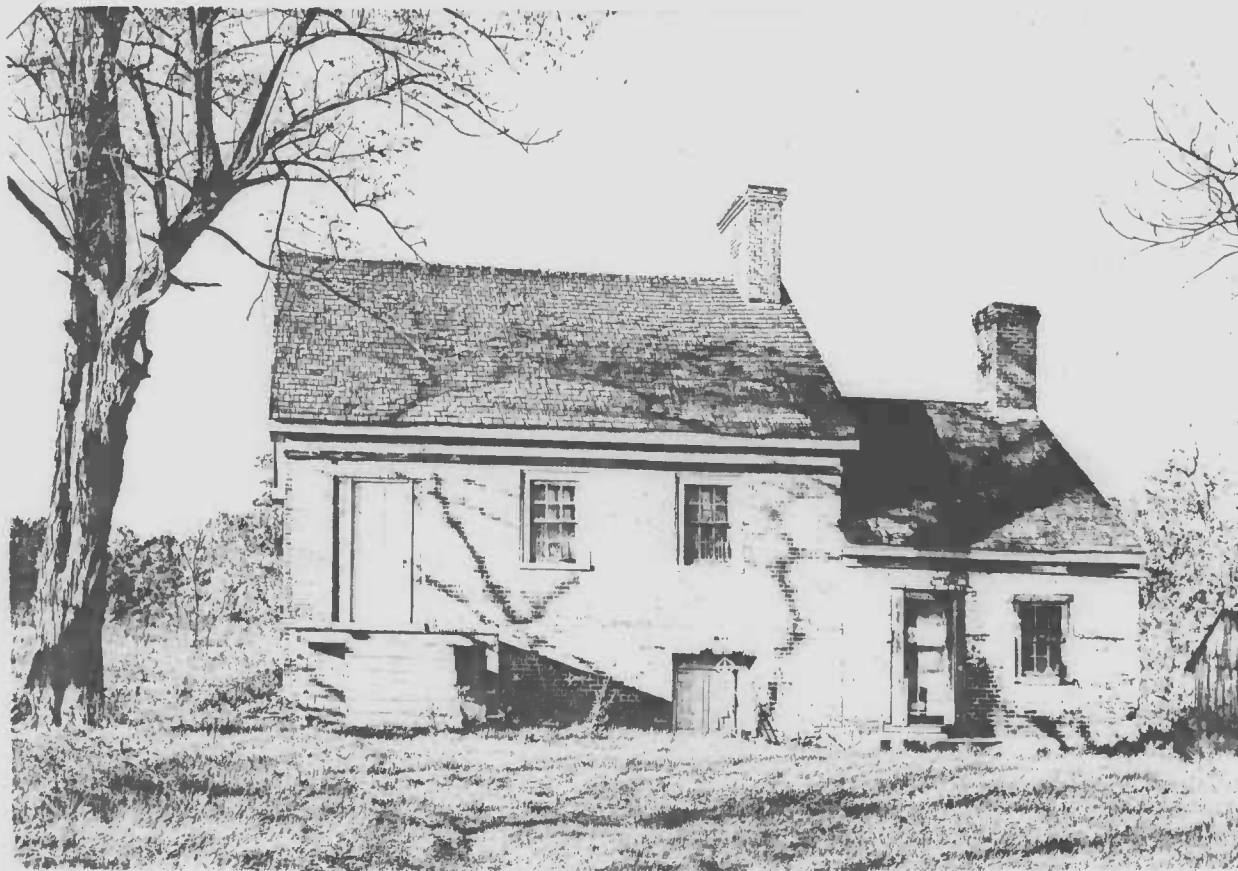
HABS No. 10,507

VIEW OF MILLER'S HOUSE FROM SOUTH (front)

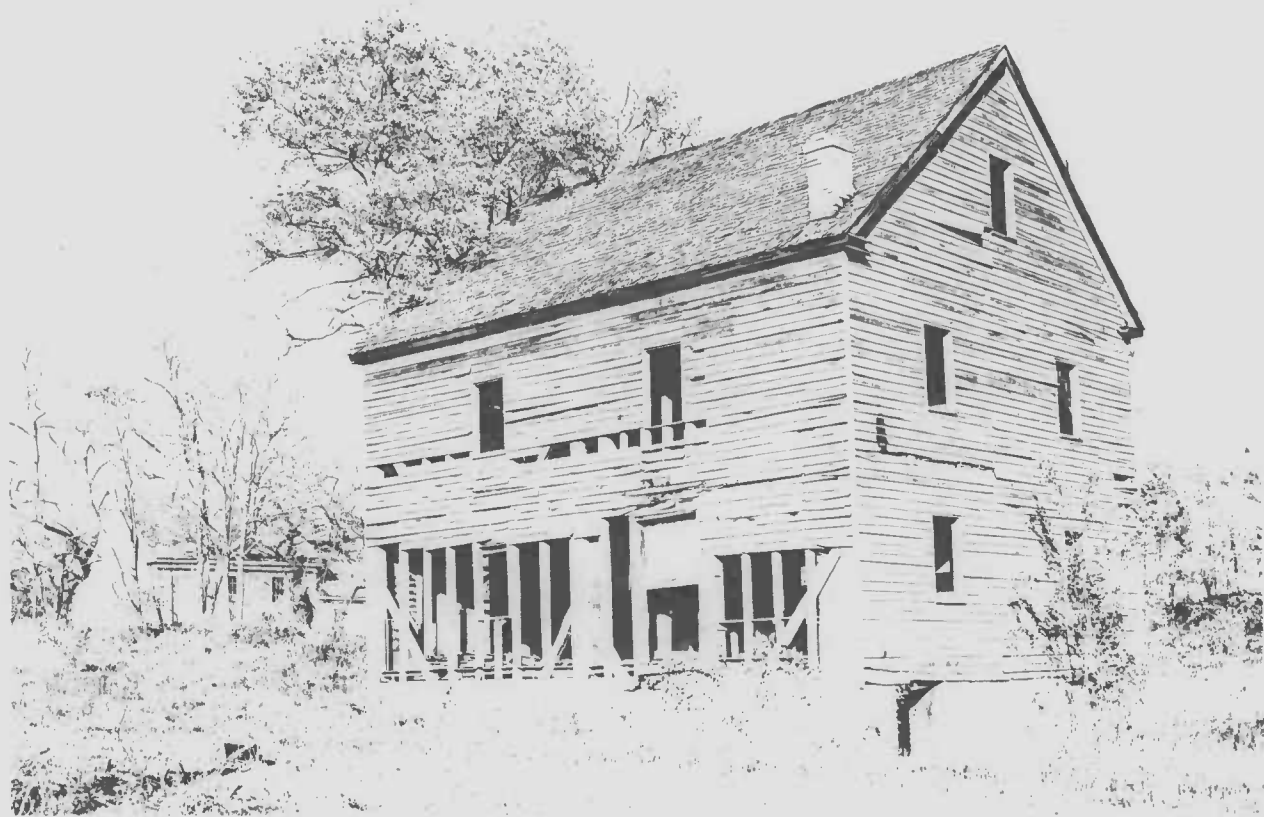
HABS No. 112-568

VIEW FROM SOUTHWEST

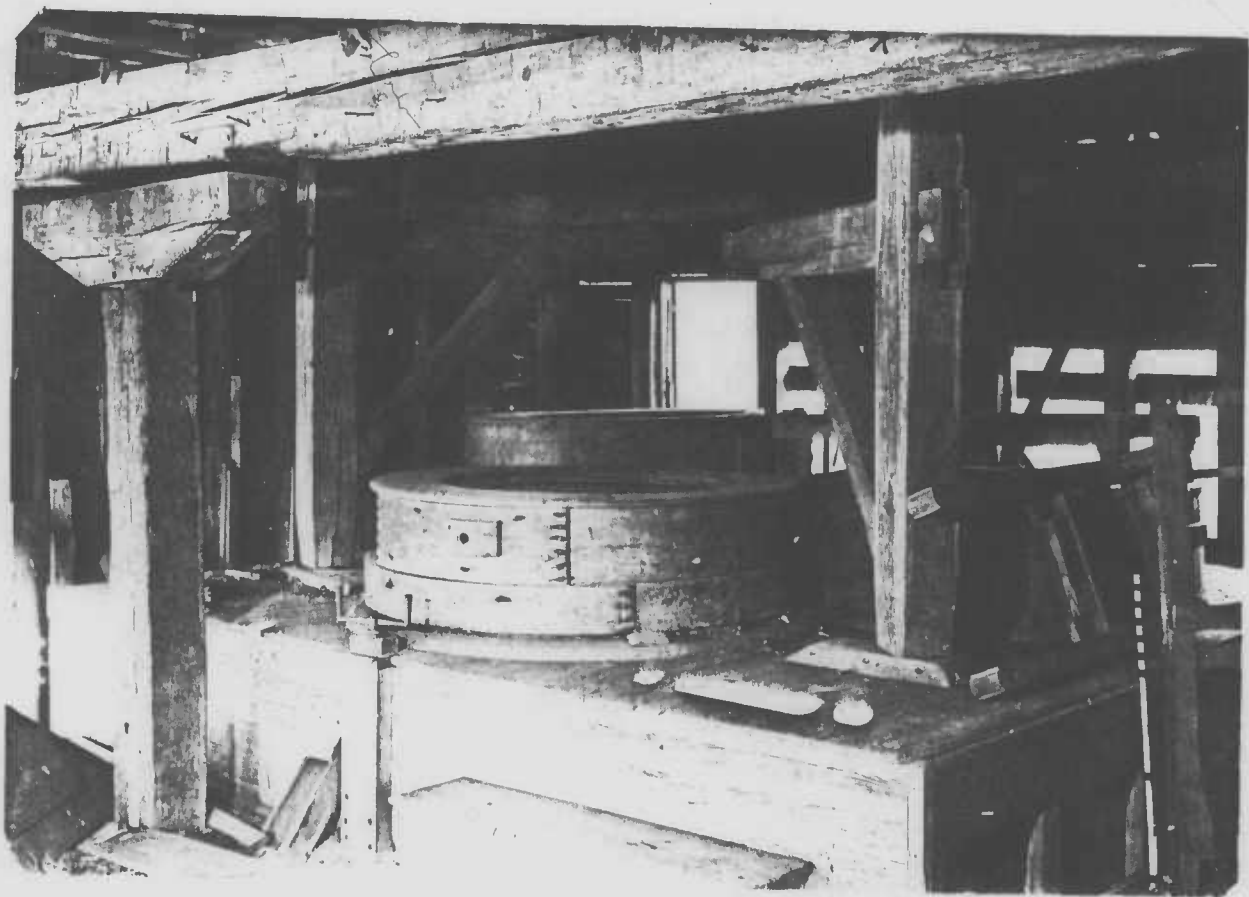
HABS No. MD-568

DETAIL OF MILL STONE TABLE

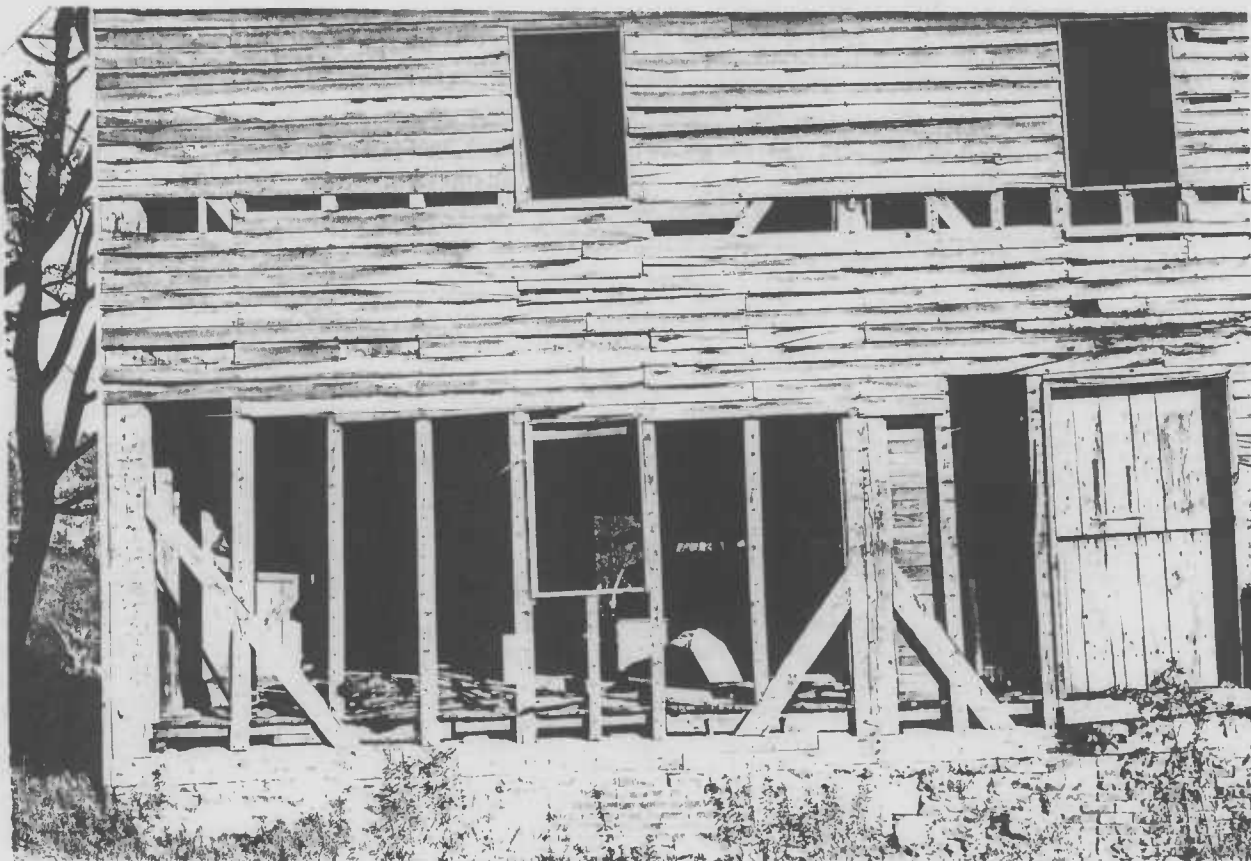
HABS No. Md-566
HABS
M.D.

DETAIL OF FRAMING CONSTRUCTION WEST ELEVATION.

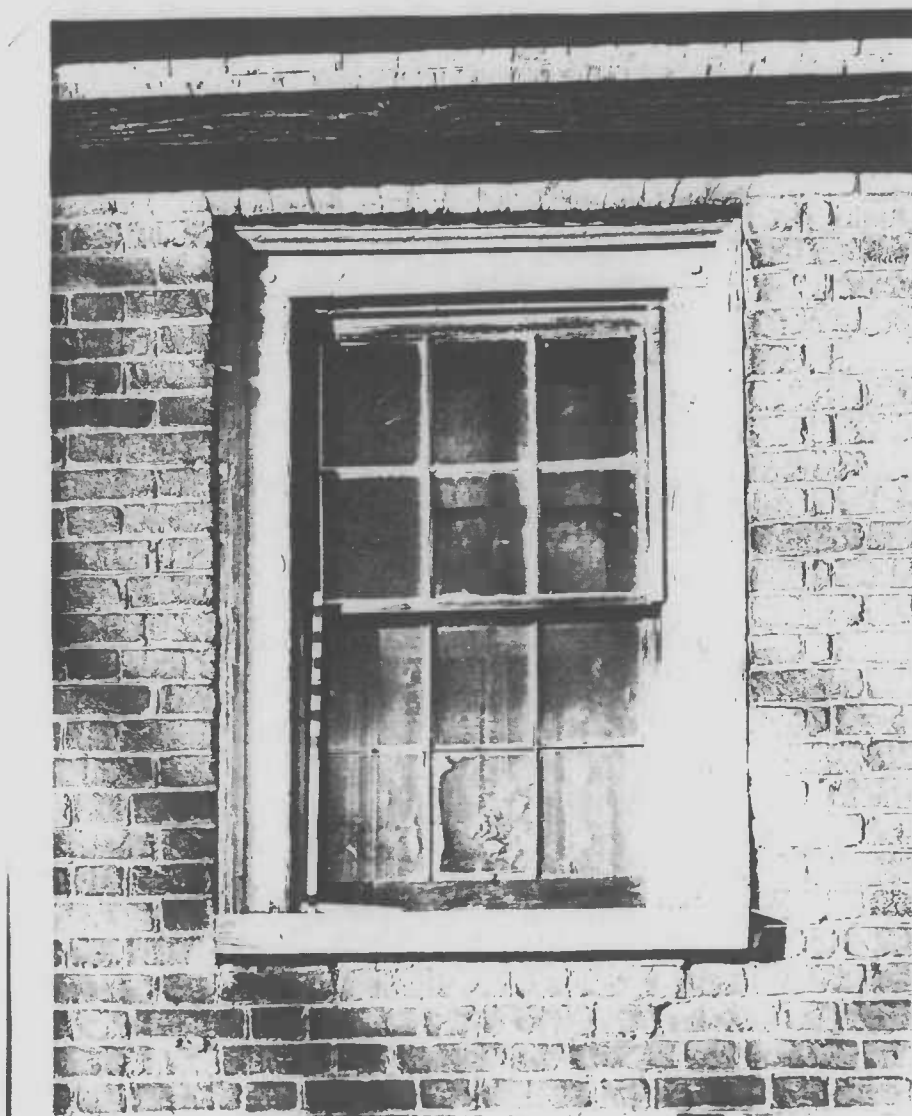
M:33-7
HABS No. MD-567

The brick work on the south facade is Flemish bond, while the sides and the rear are done in common bond. Some decorative features in the brick work include a water table, and random glazed bricks.

DETAIL OF WINDOW AND BRICK WORK

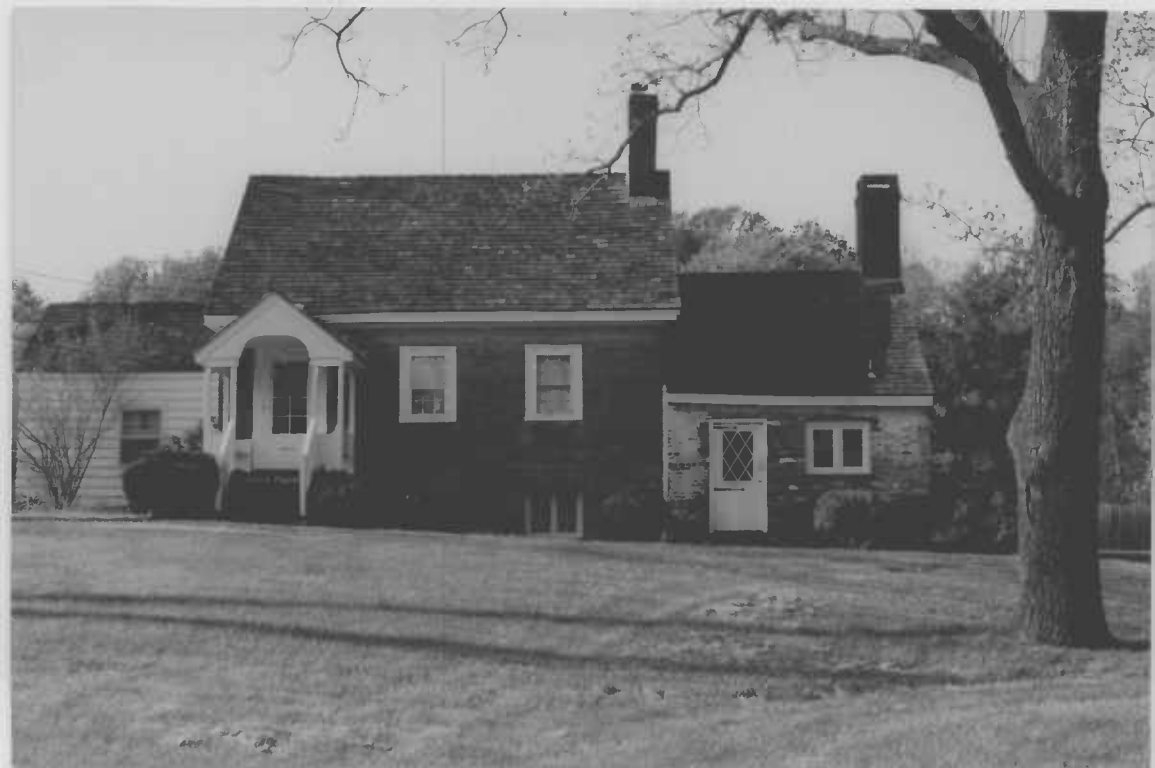
1. Valley Mill House
2. Mont. Co. MD
3. Chris McKneely
4. April 30, 1992
5. 3816 Delano St
Silver Spring, MD 20902
6. South facade, looking north.

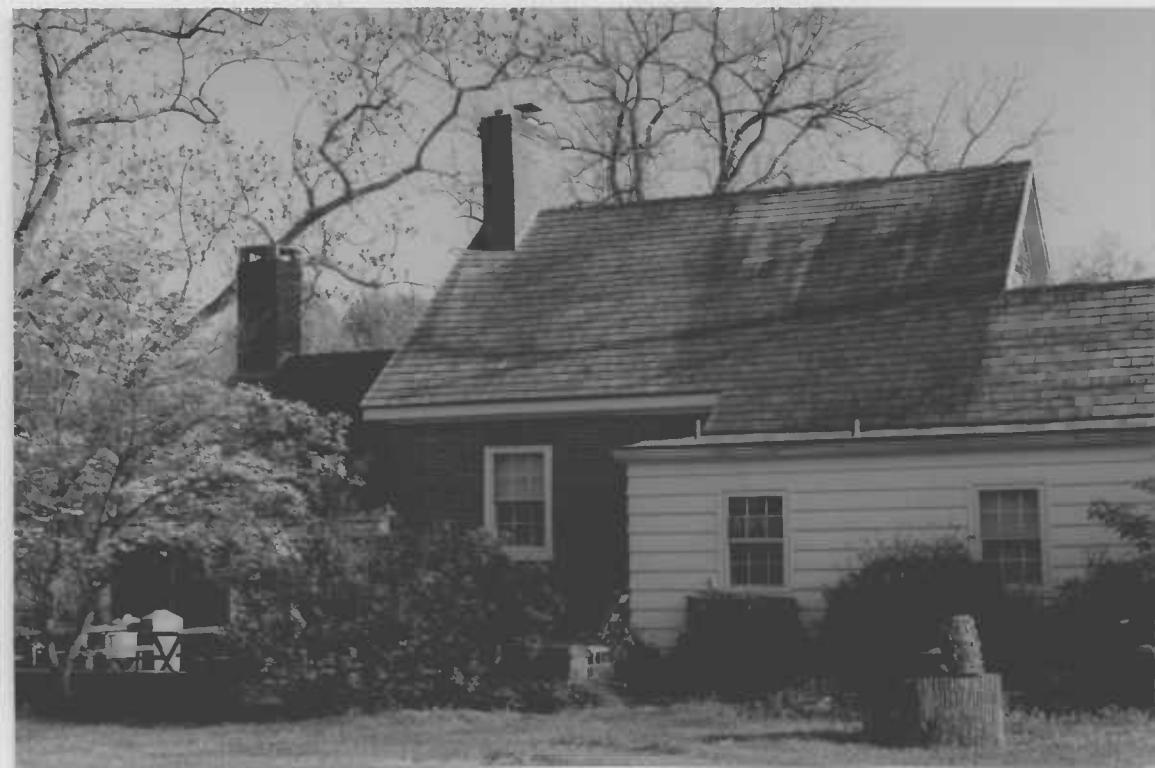
1. Valley Mill House
2. Mont. Co. MD.
3. Chris McKneely
4. April 30, 1992
5. 3816 Delano St
Silver Spring, MD 20902
6. North facade, looking southeast.

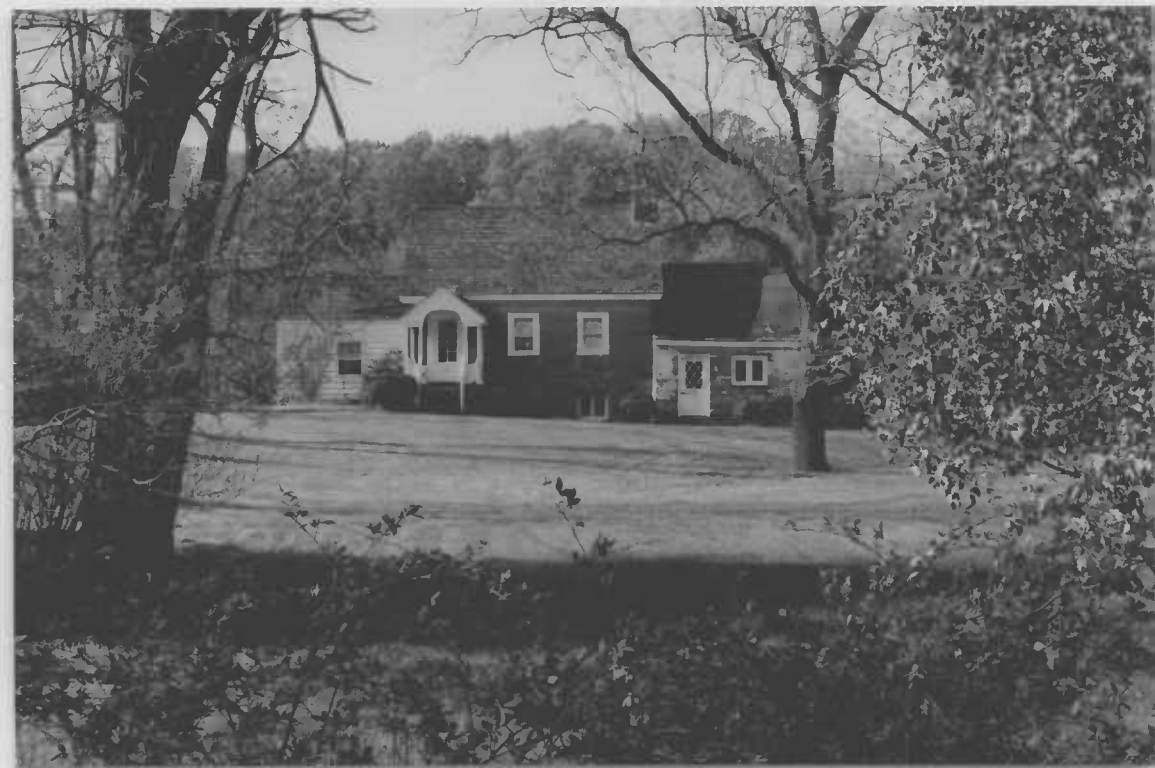
1. Valley Mill House
2. Mohr. Co. MD
3. Chris McKneely
4. April 30, 1992
5. 3816 Delano St.
Silver Spring, MD 20902
6. South facade, looking north
from East Randolph Rd.

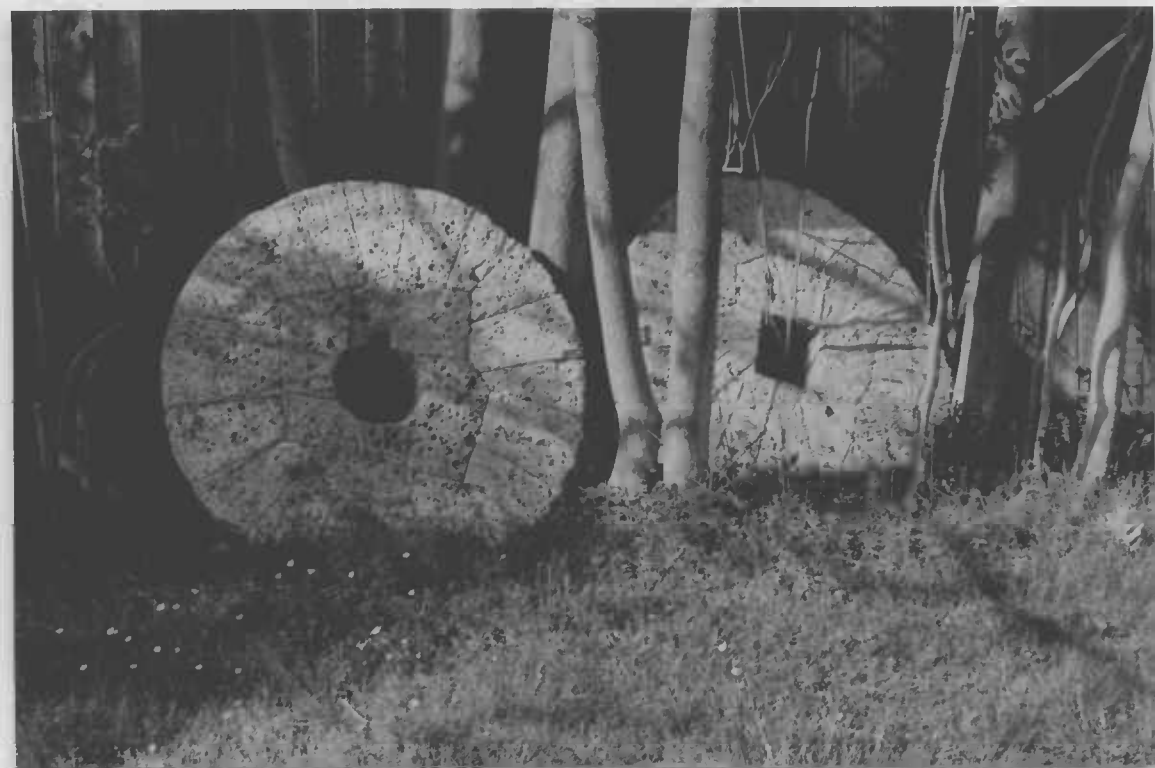
1. Valley Mill millstones
2. Mont. Co. MD
3. Chris McKneely
4. April 30, 1992
5. 3816 Delano St.
Silver Spring MD 20902
- 6.

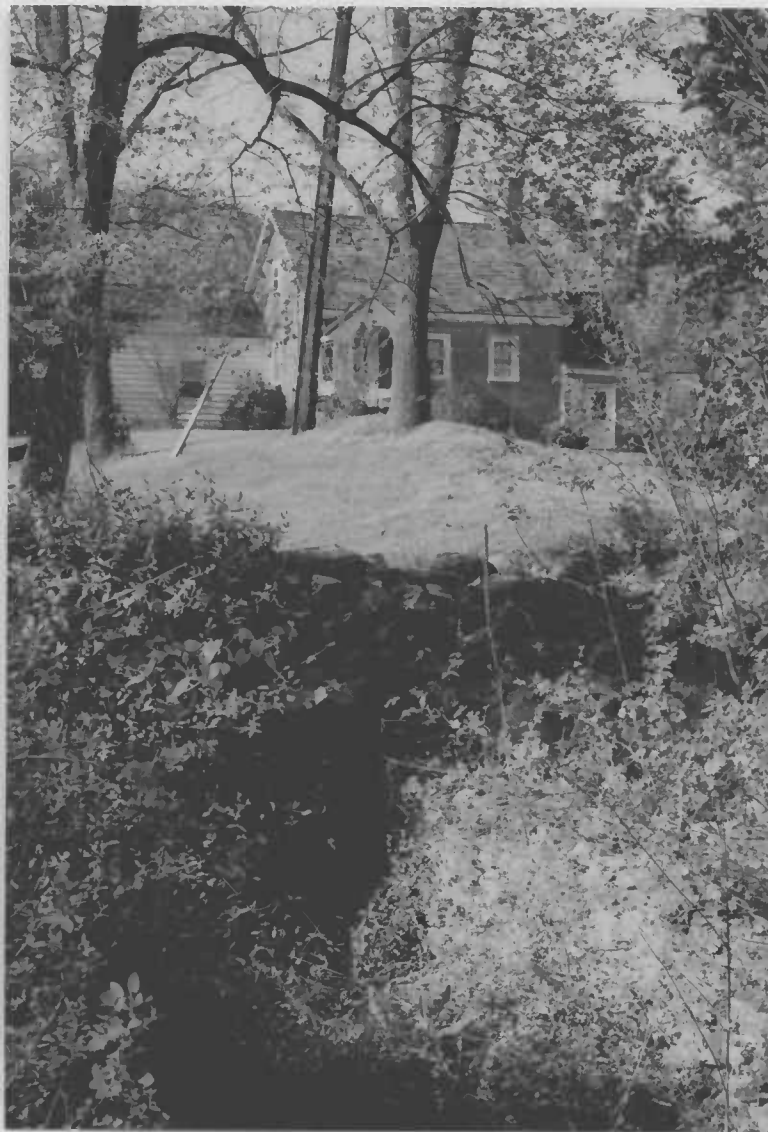
1. Valley Mill site and Valley Mill House.
2. Montgomery County, MD.
3. Christopher McKneely
4. April 30, 1992
5. 3816 Delano St.
Silver Spring, MD 20902
6. South facade from site
of old mill, looking northeast.

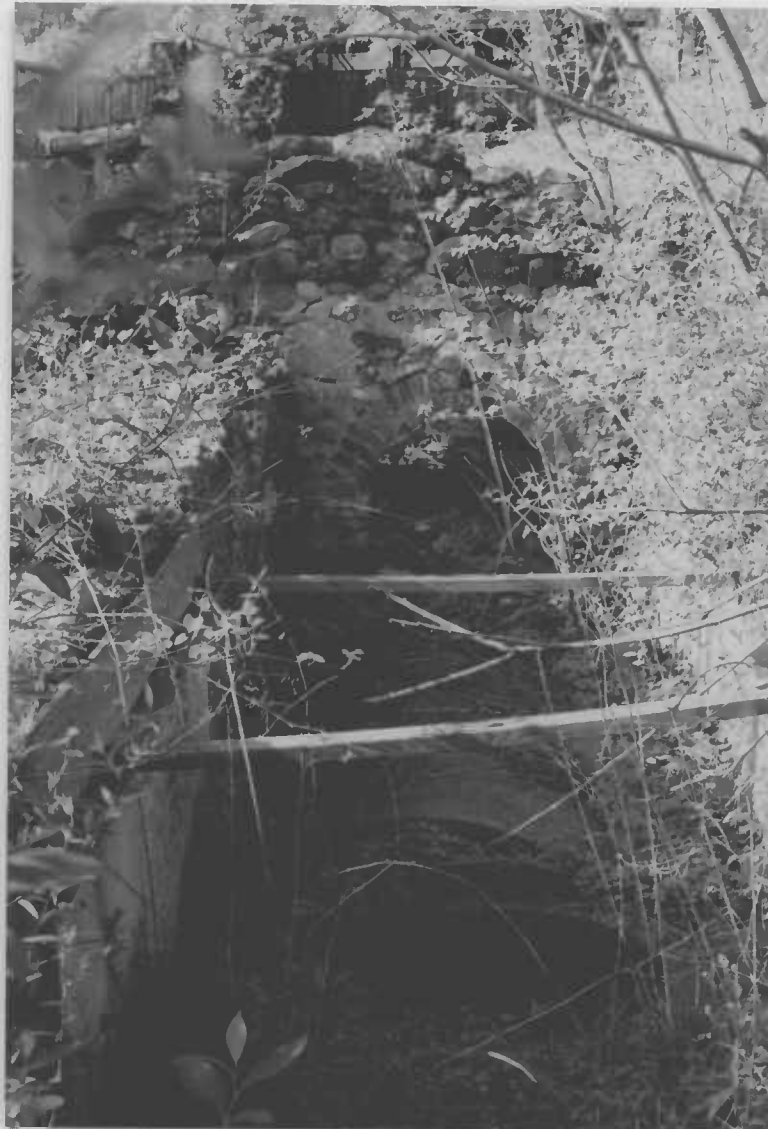
The mills foundation is of random laid stone construction. The mill measured approximately 30 feet by 30 feet, with a ground floor from three to four feet below ground level. An inner wall or separation is apparent; it is about eight inches wide and divides the ground floor into a one-fourth and three-fourths arrangement. From floor level to top the walls measure eight feet at the highest point. The last mill to operate this site was constructed in 1879 and was a two and a half story frame building covered in horizontal siding with a gable roof covered in wooden shingle. A brick chimney rose from the southwest corner of the mill building.

1. Valley Mill
2. Mont. Co. MD.
3. Chris McKneely
4. April 30, 1992
5. 3816 Delano St.

6. North and interior foundation walls, looking north.
